Polychrome from the southern crypt of the church of the Holy Trinity in Byszewo in light of archaeological and conservation studies

Nowak S., Kaźmierczak A. 2019. Polychrome from the southern crypt of the church of the Holy Trinity in Byszewo in light of archaeological and conservation studies. *Analecta Archaeologica Ressoviensia* 14, 169–185

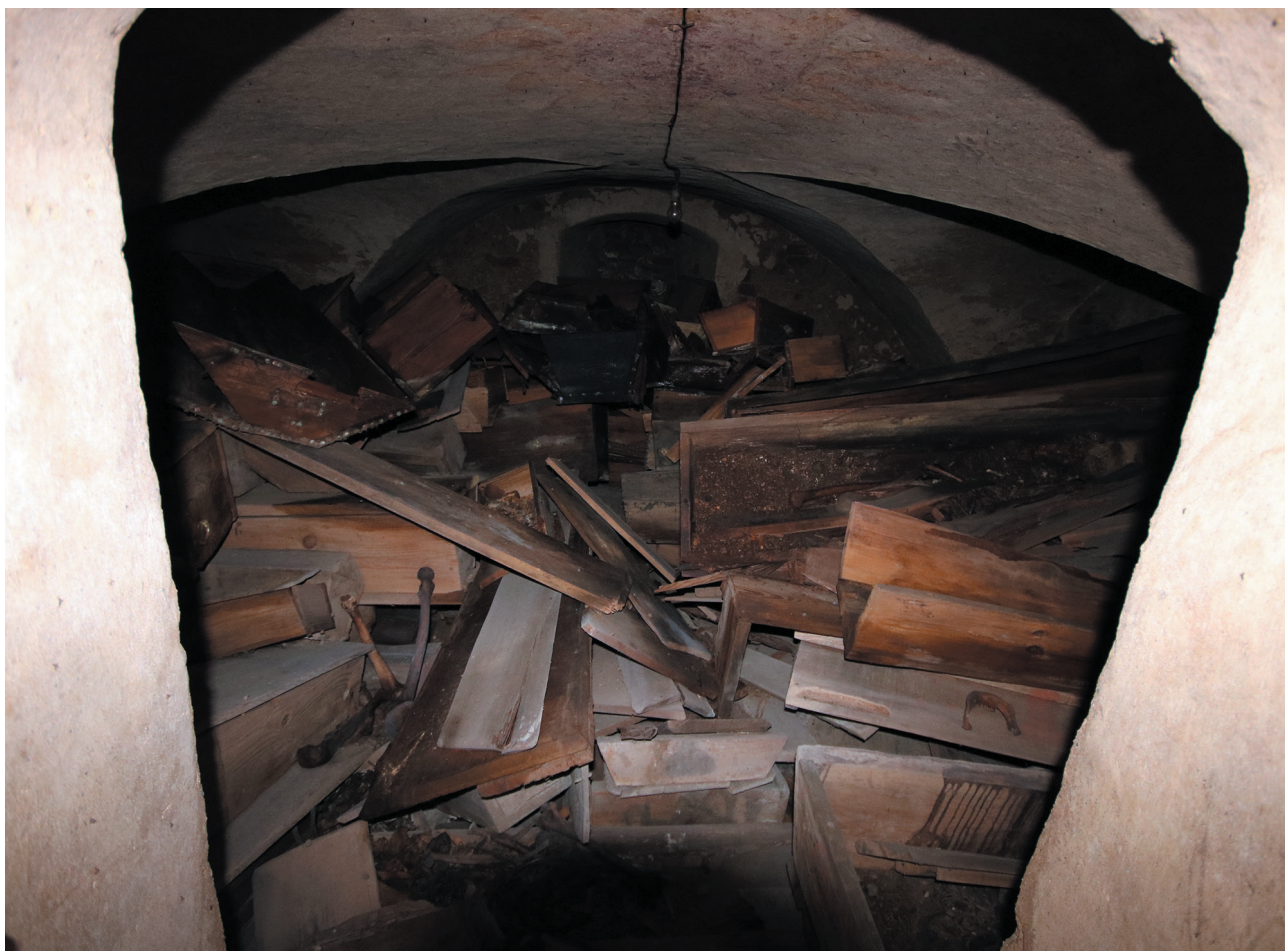
Fig. 1. The state of the southern crypt after removing the protective wall which had closed the entrance. Irregular burial layers seen throughout the whole space. Photo by M. Majorek.

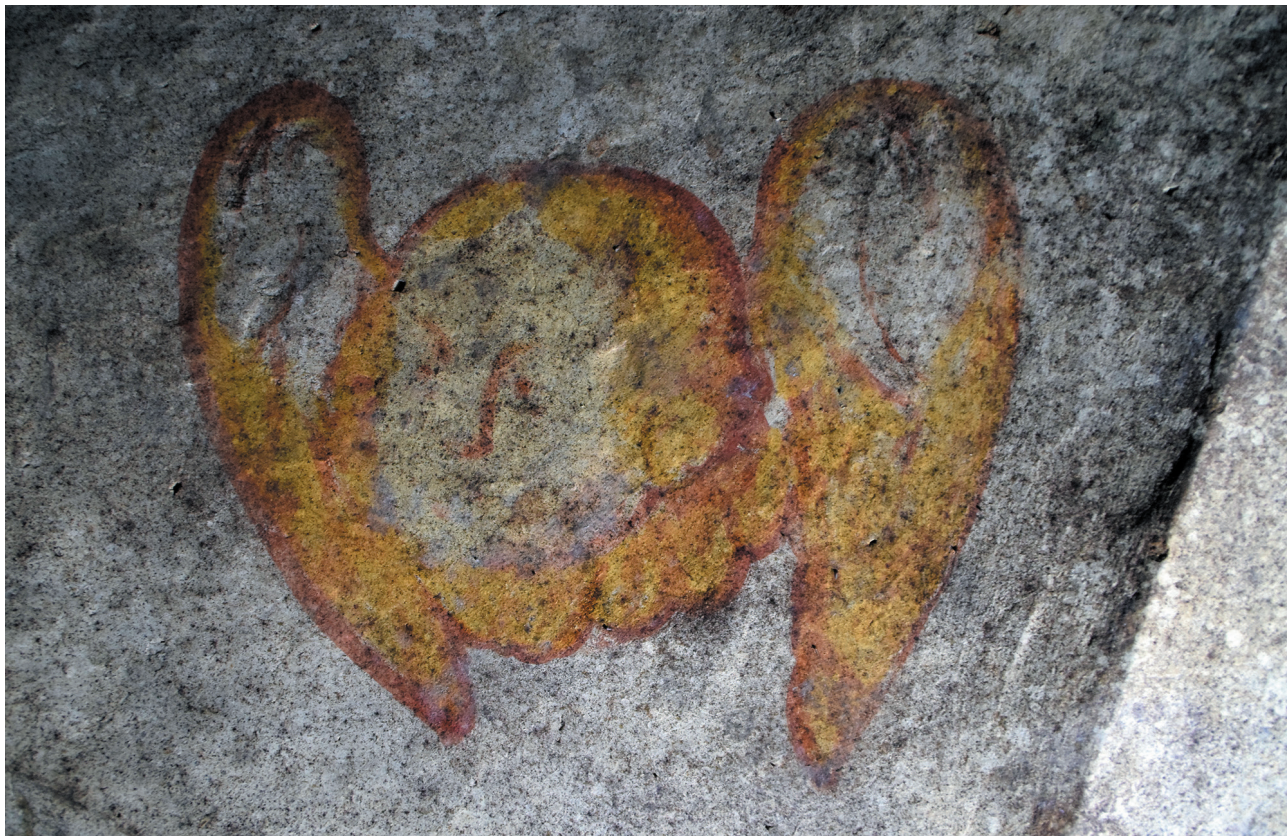
Fig. 7. Putto in the eastern lunette. Photo by A. Kaźmierczak.

The putti are painted similarly, but the western one is preserved in a much poorer condition than the eastern one (Fig. 7–8). The figure composition was made here first of all using a red line. Their yellow faces are round and chubby. Only the large almond eyes and straight noses are schematically marked with red, and the lips were probably made in the same way (the least readable). The putti's yellow hair is short, with red painted weaves and locks. Under their heads there are single fragments of feathers and, at the sides, yellow-or-

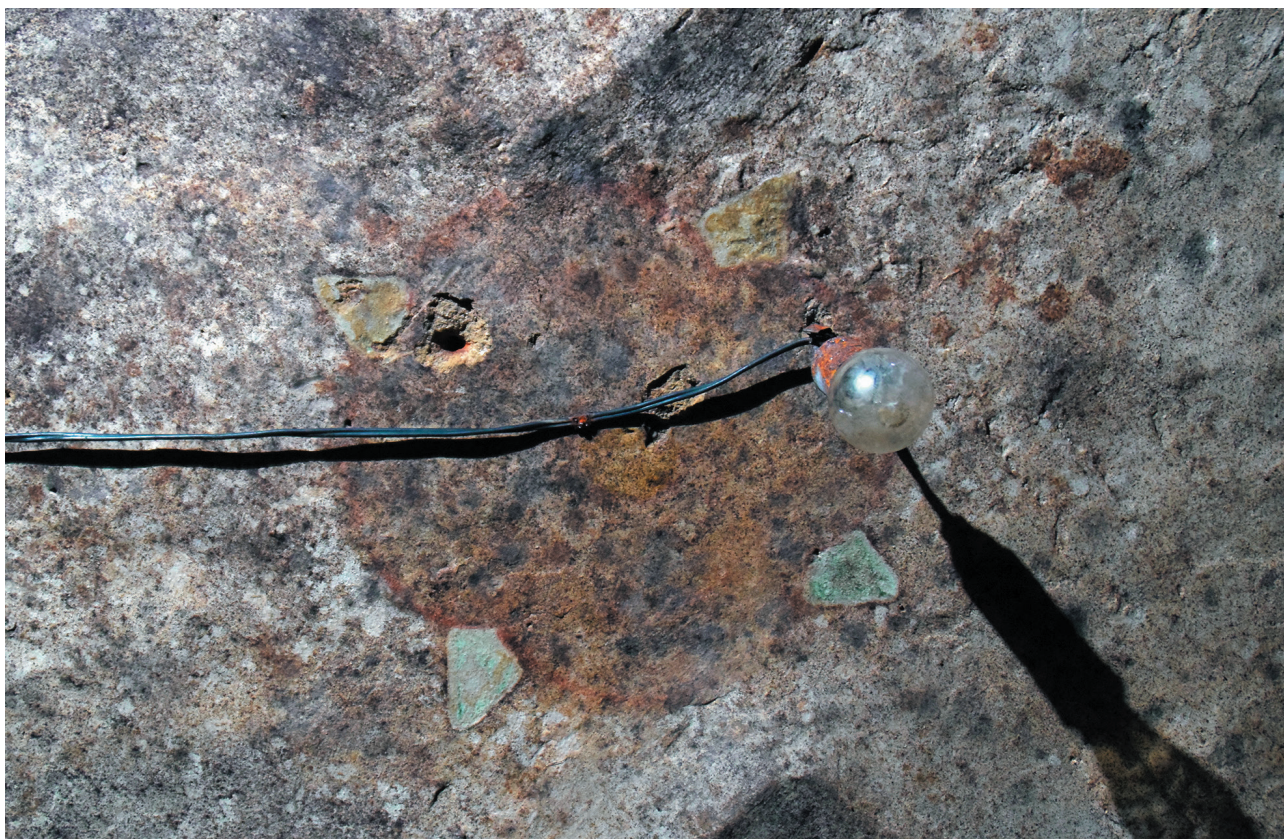
Fig. 9. A flower in the central crypt vault section. Photo by A. Kaźmierczak.

A primitive flower in the middle of a vault (Fig. 9) has four rounded bright orange petals with a small round yellow center lined in red. Straight malachite leaves are small and close triangles. All elements are lined in red.

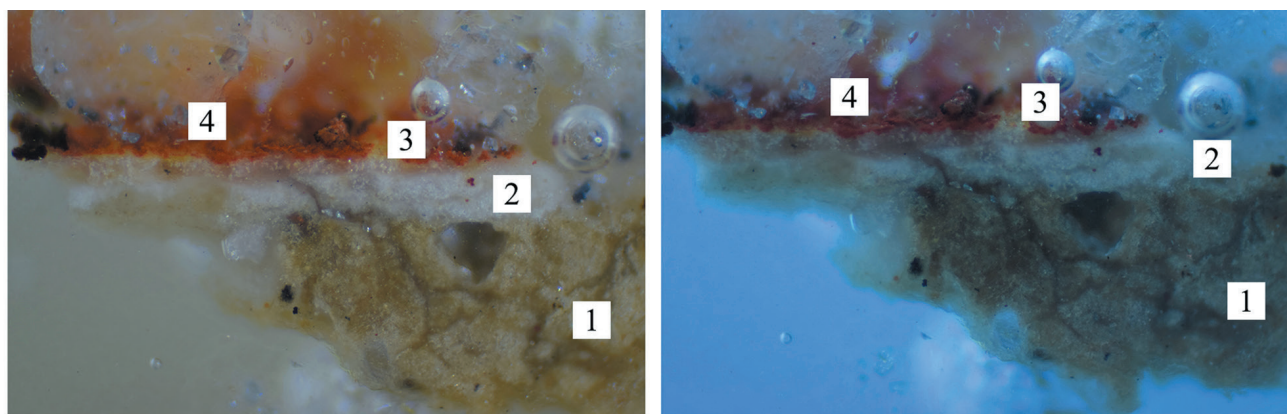
Fig. 11. Microscope pictures of the red cross-section from the southern 'glory' ray in VIS and UV lights, magnification 40×. The pictures show the layers of the composition of the vault's completion: 1 – lime-sand plaster, 2 – whitewash, 3 – yellow paint layer, 4 – red paint layer. The diagram contains the pigments and binding present, with the elements identified using spectral analysis XRF and the brief characteristics of a layer. Photo and compilation A. Kaźmierczak.

A yellow layer (Fig. 11–12) contained ochre and a protein binder (probably tempera), while the green-blue (Fig. 13) had malachite and a chalk and protein

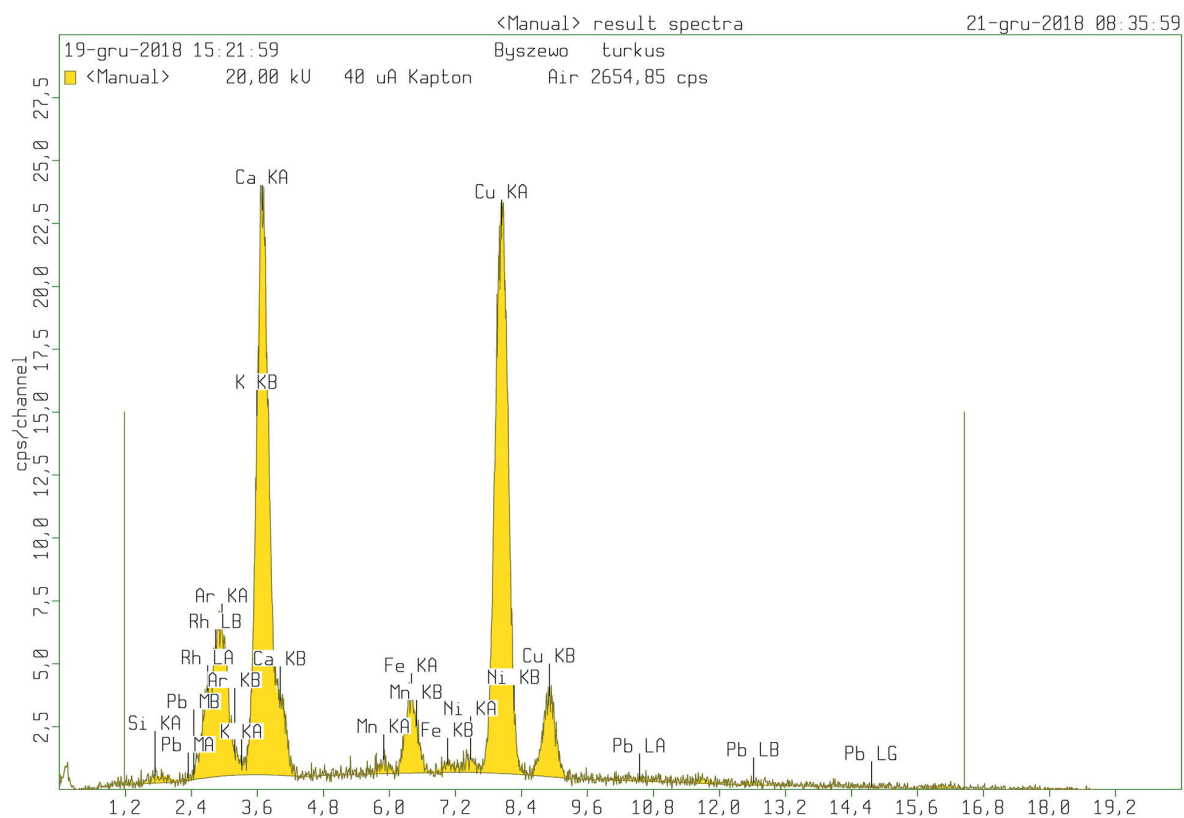
Fig. 15. X-ray fluorescence spectrum obtained from the green-blue paint layer on a leaf of the flower in the central vault section. The presence of Ca, Cu, Fe, Mn, K and Si are evidenced.

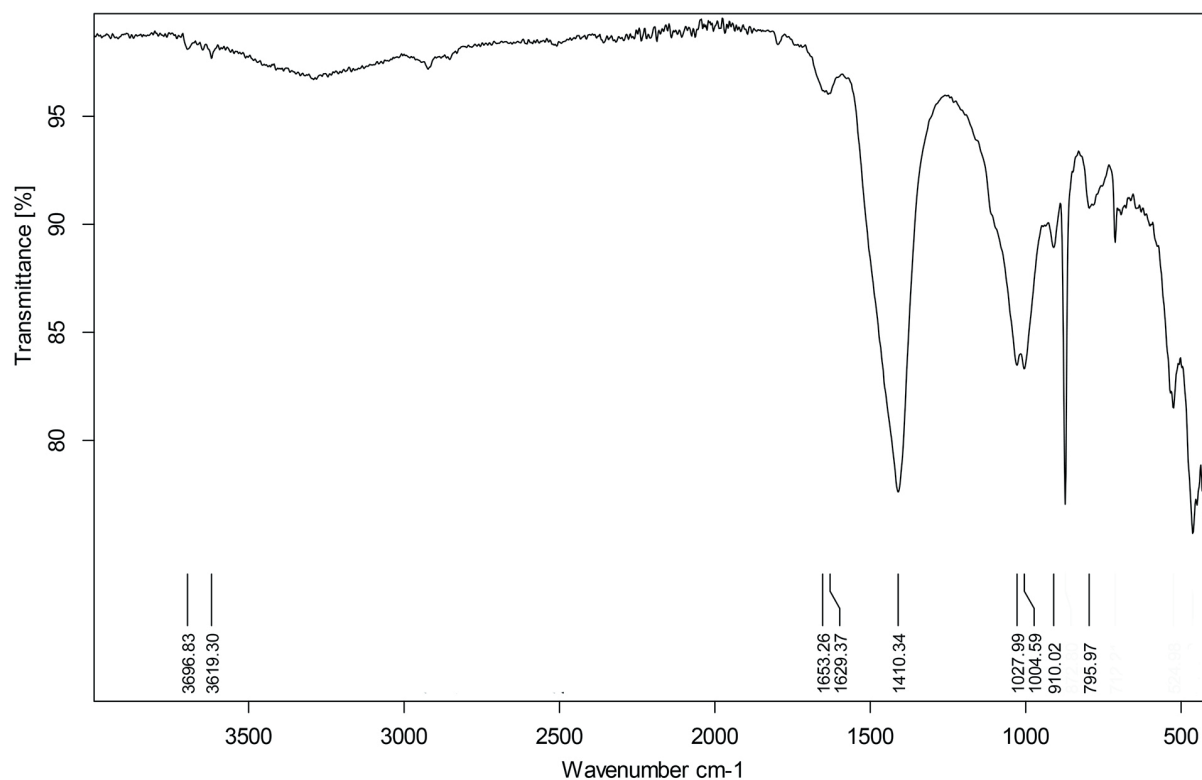
Fig. 16. Infrared spectrum of yellow from a sample in the southern glory. Amide bands identified at 1653.26 and 1629.37 cm^{-1} , confirming the presence of a protein binder. The strong band at 1410.34 cm^{-1} , can be attributed to the presence of whitewash carbonates. Bands at 3696.83, 3619.30, 1027.99, 1004.59, 910.02 and 795.97 cm^{-1} refer to an ochre spectrum pattern.
