## Research on the Bridge in Jestřebí, Česká Lípa District, Czech Republic

Martyčák S. 2023. Research on the Bridge in Jestřebí, Česká Lípa District, Czech Republic. *Analecta Archaeologica Resso- viensia* 18, 217–233

The aim of this article is to present to the reader with the results of the watching brief of the defunct historical bridge in Jestřebí, Česká Lípa district. The research brought new knowledge about the construction technology and dating of the bridge. The new findings are then placed in context with the information gathered to date about other bridges in the Česká Lípa region in North Bohemia.

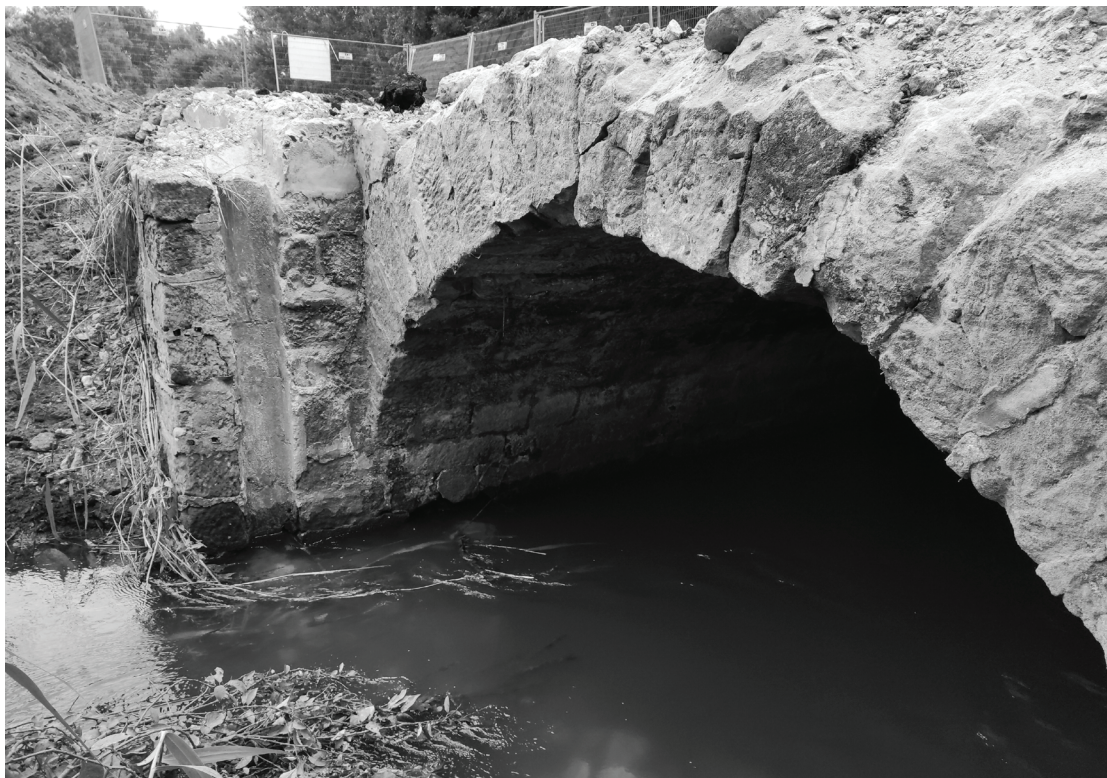
**Fig. 6.** Front view of the bridge vault on the upstream side with a groove used for waterflow regulation (source: VMG archive).

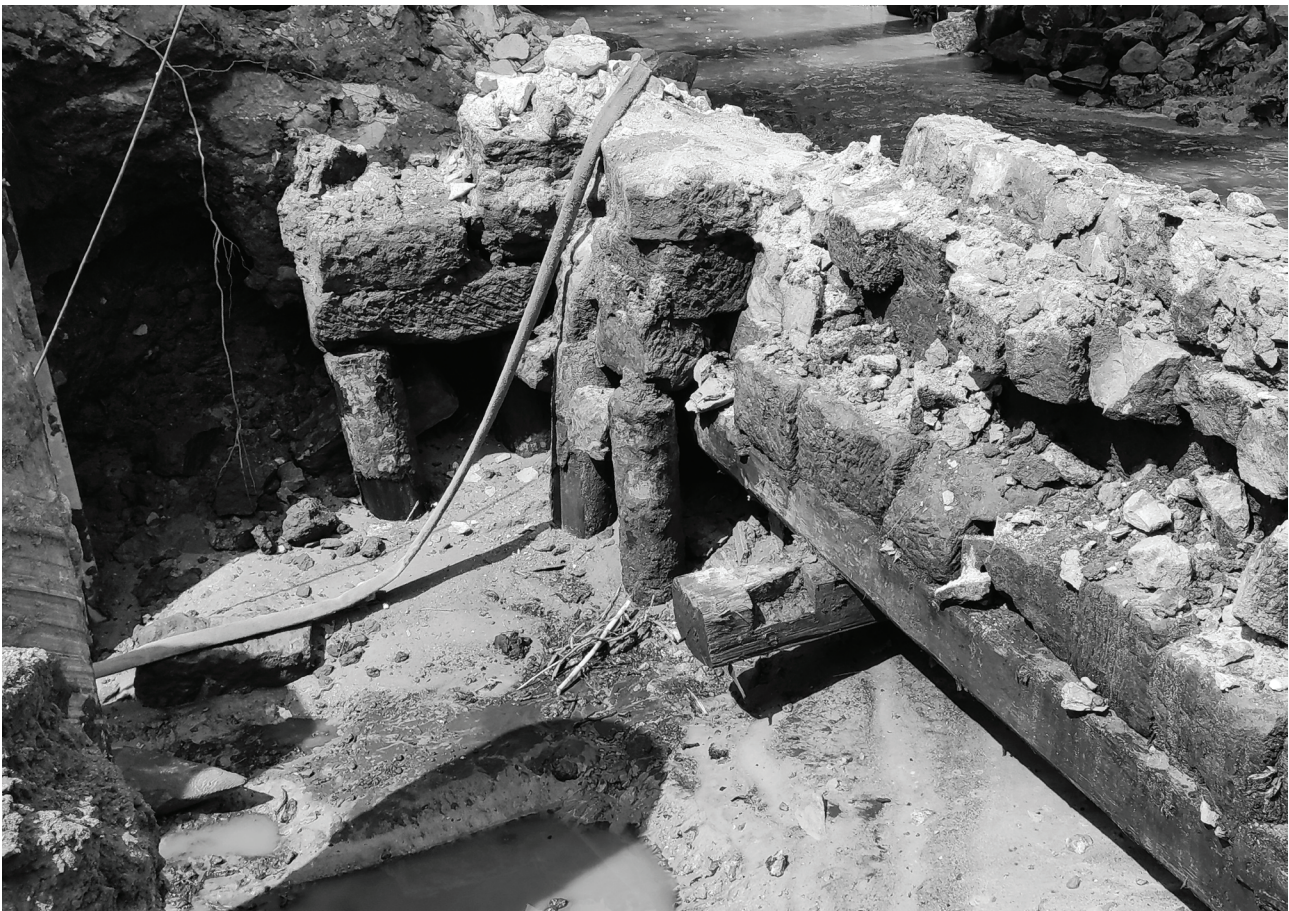
**Fig. 7.** View of the uncovered individual piles and grid beams under the abutment on the left bank of the stream. In the front right, a short transverse beam with mortises that were not used in the bridge construction (source: VMG archive).

The masonry structure of the bridge itself, made of worked sandstone blocks, consisted of left (north-west) (Fig. 7) and right (southeast) bridge abutment, which supported a semicircular bridge vault. The foundations of the abutments were laid on wooden fir edged beams parallel to the bridge abutments, two

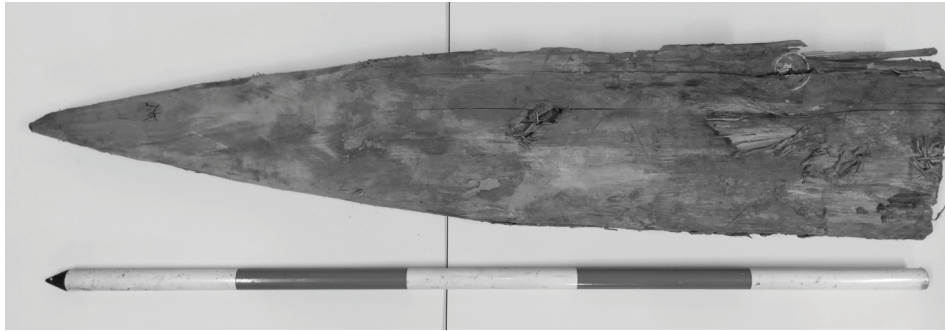
**Fig. 8.** The pilot originally placed under the foundation grid (source: VMG archive).

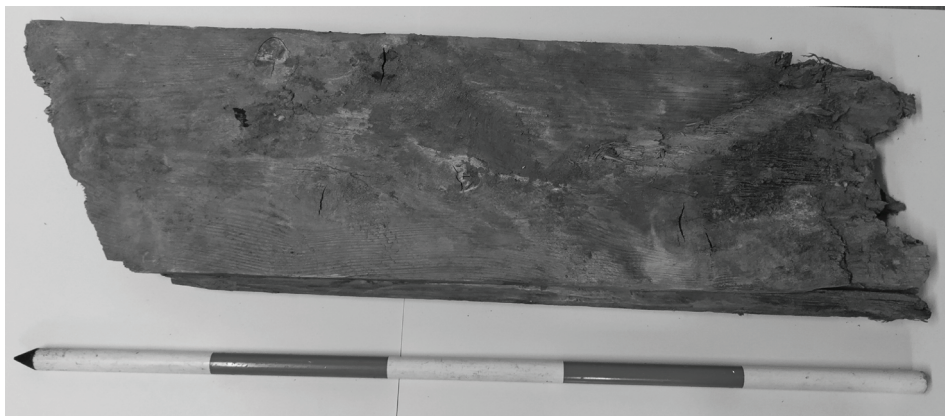
**Fig. 9.** A wooden plank with a groove, that was part of the formwork on the upstream side of the bridge (source: VMG archive).

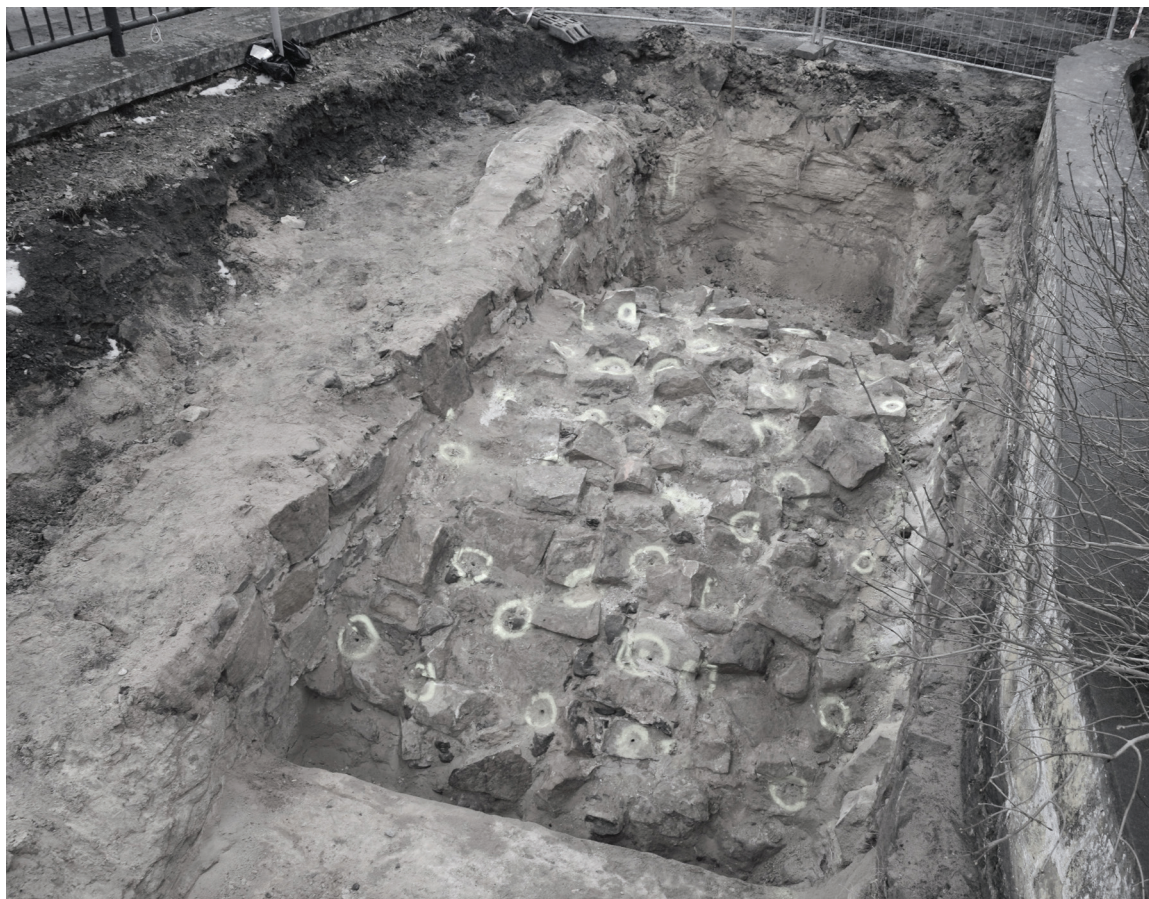
**Fig. 11.** Revealed construction of the oldest part of the bridge over Novozámecký gap in the village of Zahrádky (source: VMG archive).

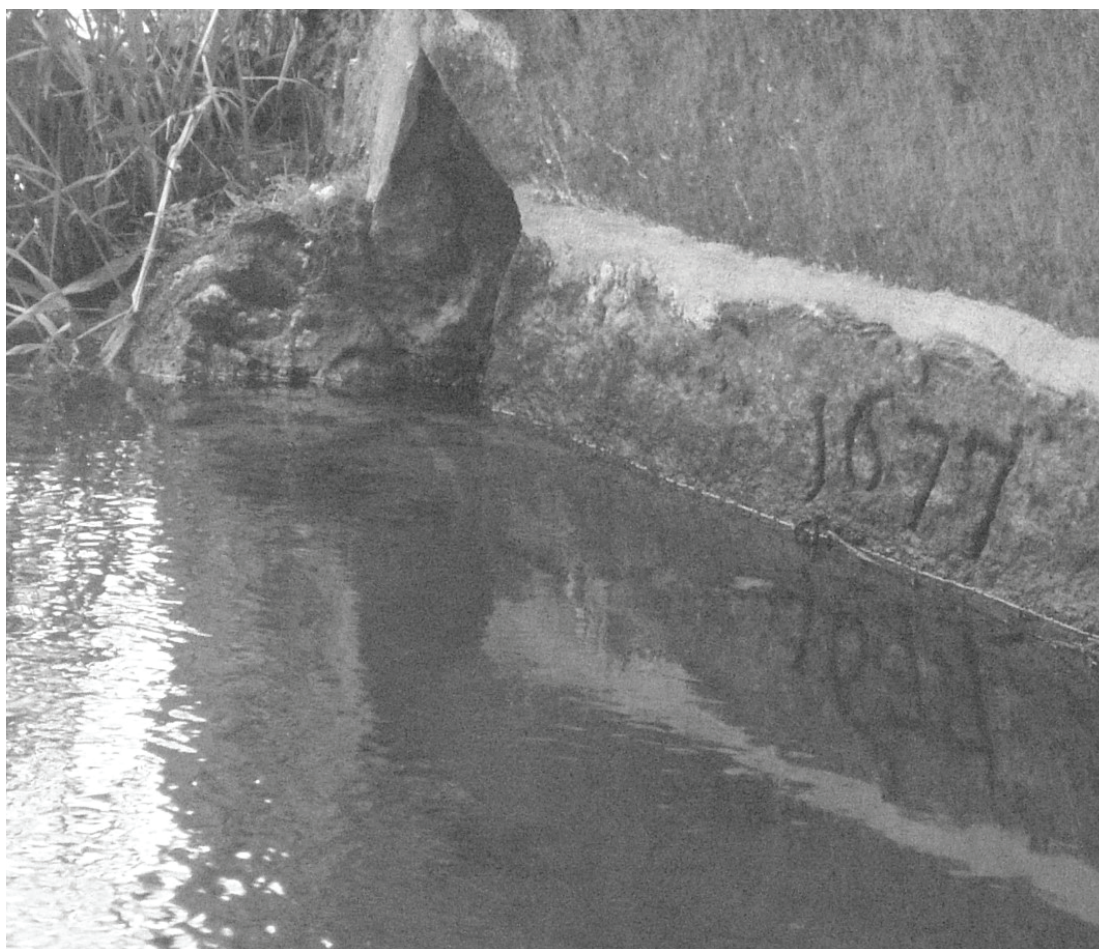
**Fig. 14.** Dating "1677" on the bridge in village of Velenice  
(source: VMG archive).

The double-arched bridge ev. no. M-014 in Velenice, Česká Lípa district over the River Svitávka is one of the oldest preserved bridges, dating back to 1677 (Fig. 14). Archaeological research only confirmed the already visible construction of the bridge and did not bring any further findings (Jenč 2016).

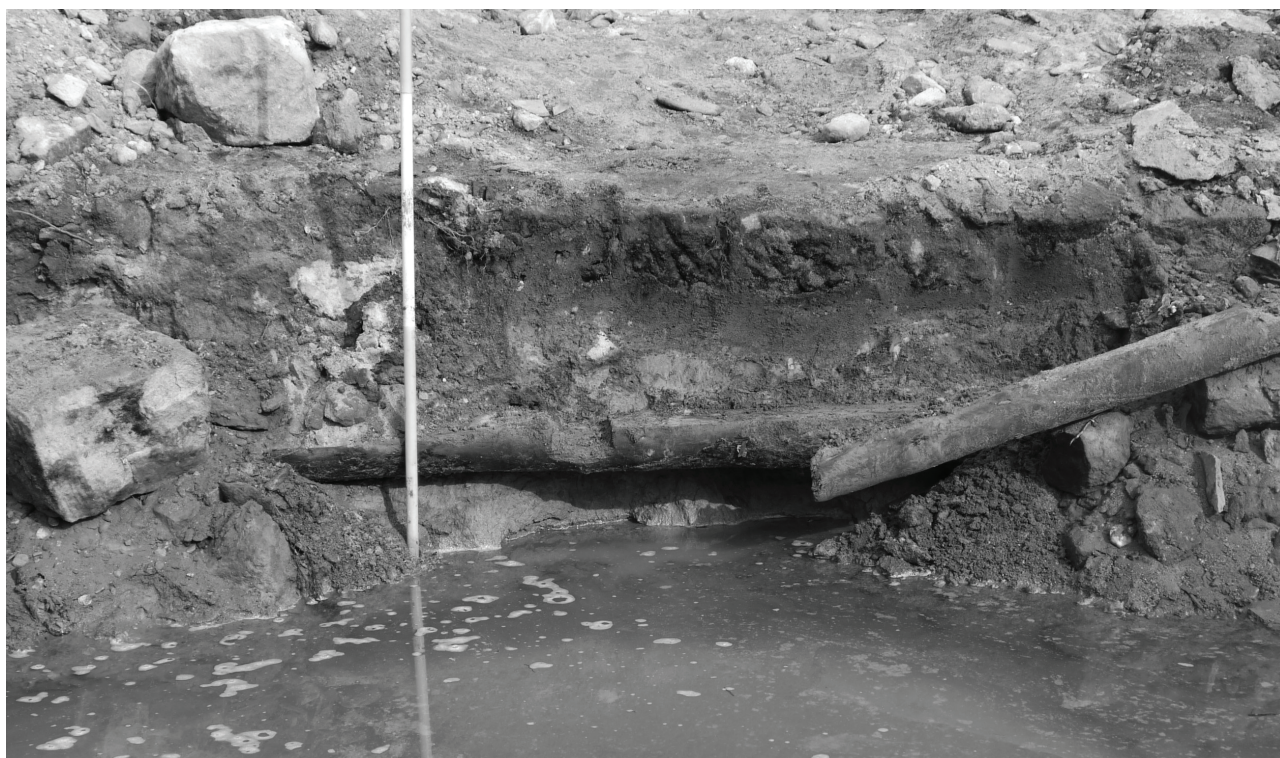
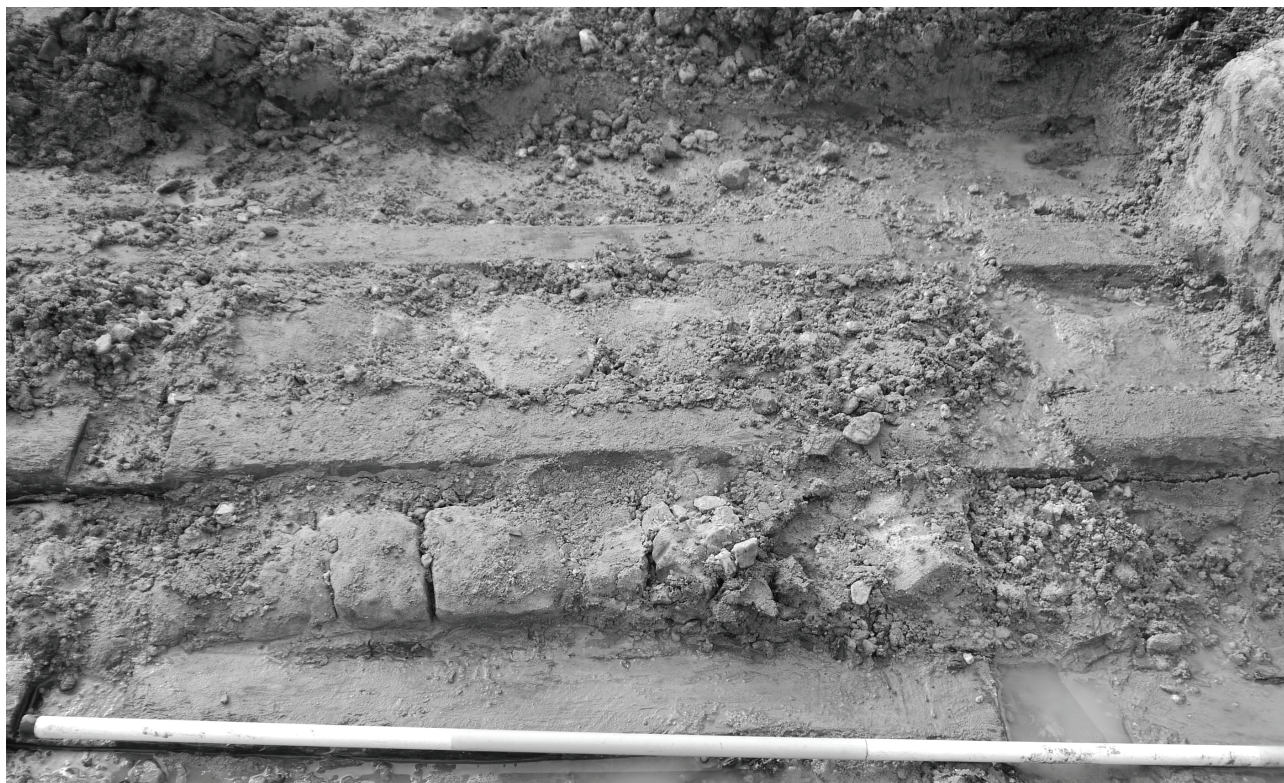
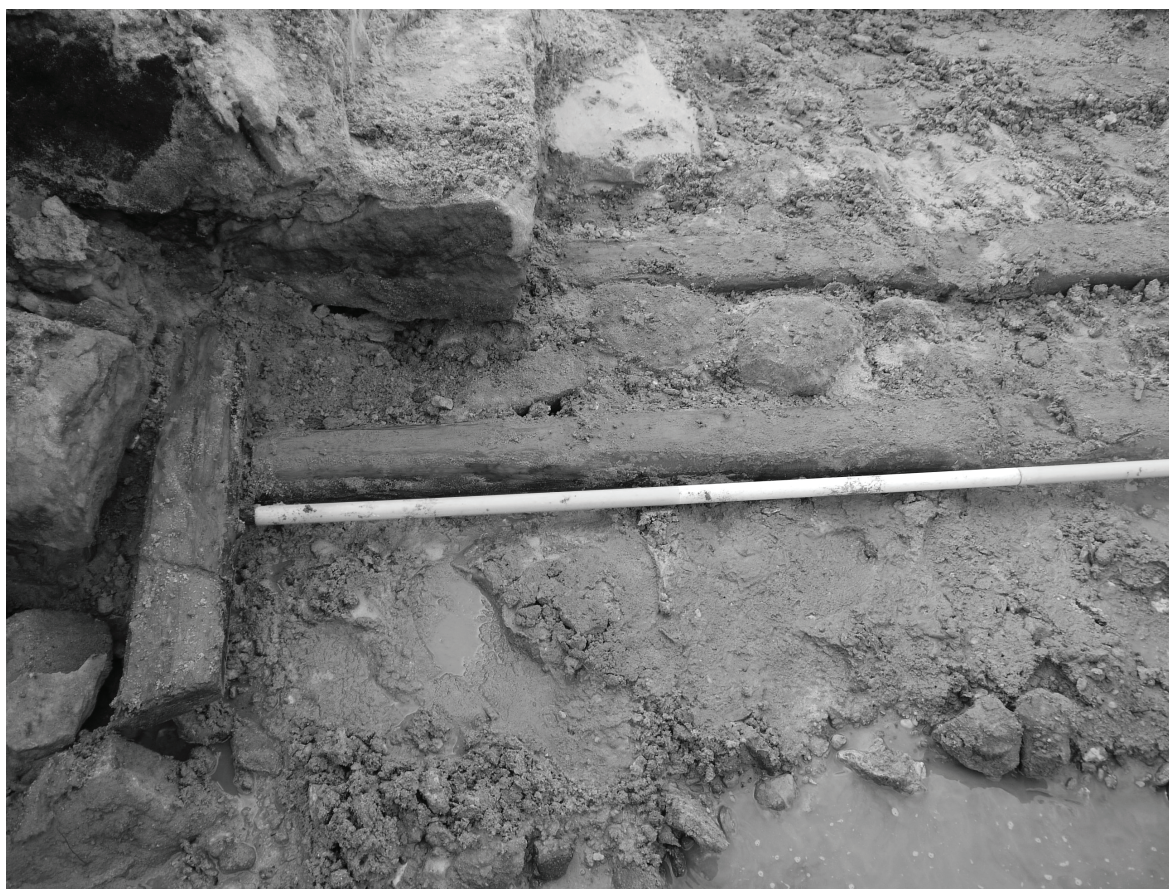
Fig. 17. Foundations of the bridge near the village of Žizníkov (source: VMG archive).

Fig. 18. Foundations of the bridge near the village of Žizníkov (source: VMG archive).

Fig. 19. Foundations of the bridge near the village of Žizníkov (source: VMG archive).

Near the village of Žizníkov, Česká Lípa district, the inundation bridge ev. no. 2623-2 with about ten pillars across the Ploučnice River was reconstructed. Its foundations were made of well-worked sandstone blocks, which in places bore traces of younger repairs with concrete. This structure rested on a well-made wooden grid (Fig. 17–19) made of pine. Dendrochronological analysis failed to determine the age of the wood. A study of the map documents revealed that the bridge is only shown on the third military map, for which reason it can roughly be dated to the period between the end of the 1840s and the end of the 1870s (Jenč 2017).

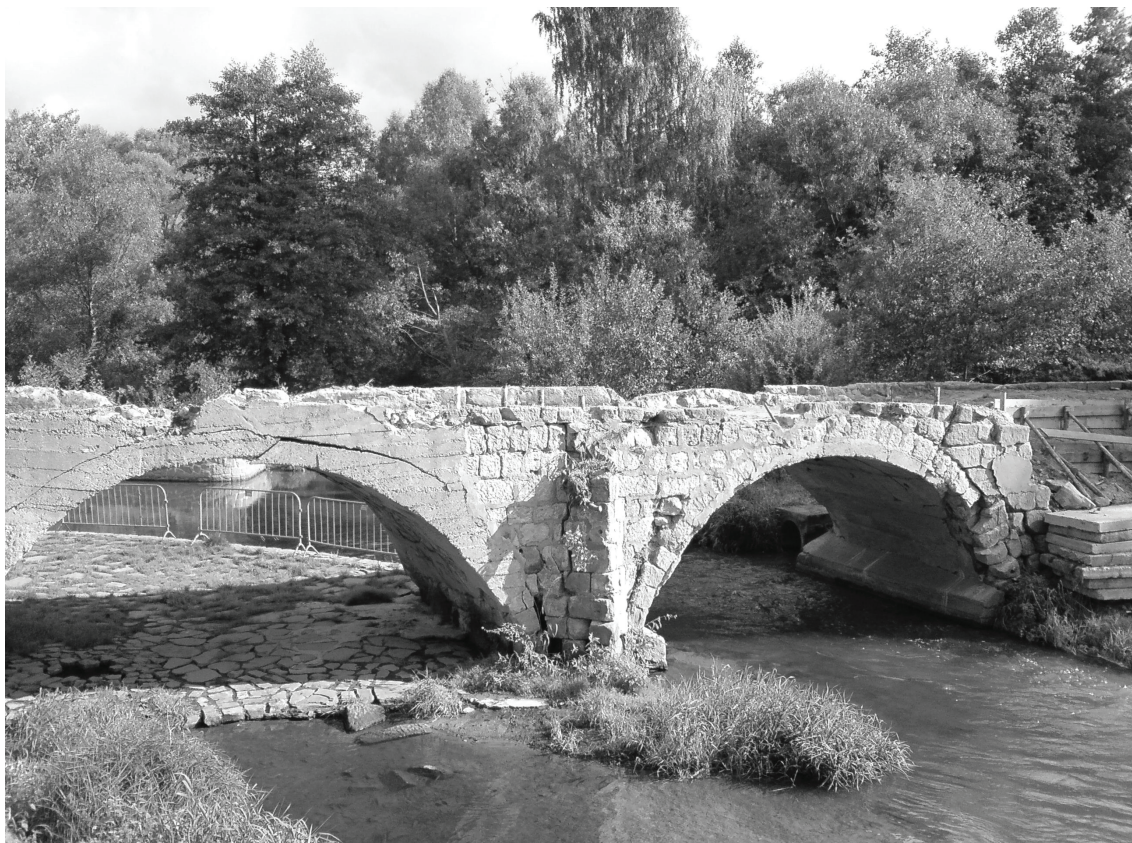
**Fig. 20.** View of the central part of the Zámecký (Castle) bridge in a prereconstruction state, city of Mimoň (source: VMG archive).

In the case of the four-arched Zámecký (Castle) bridge in Mimoň (Fig. 20), structures related to its rebuilding in 1805 and after 1832 were captured (Fig. 21, 22), when a fir beam was found from the foundation part of the third pillar from the west, on its western

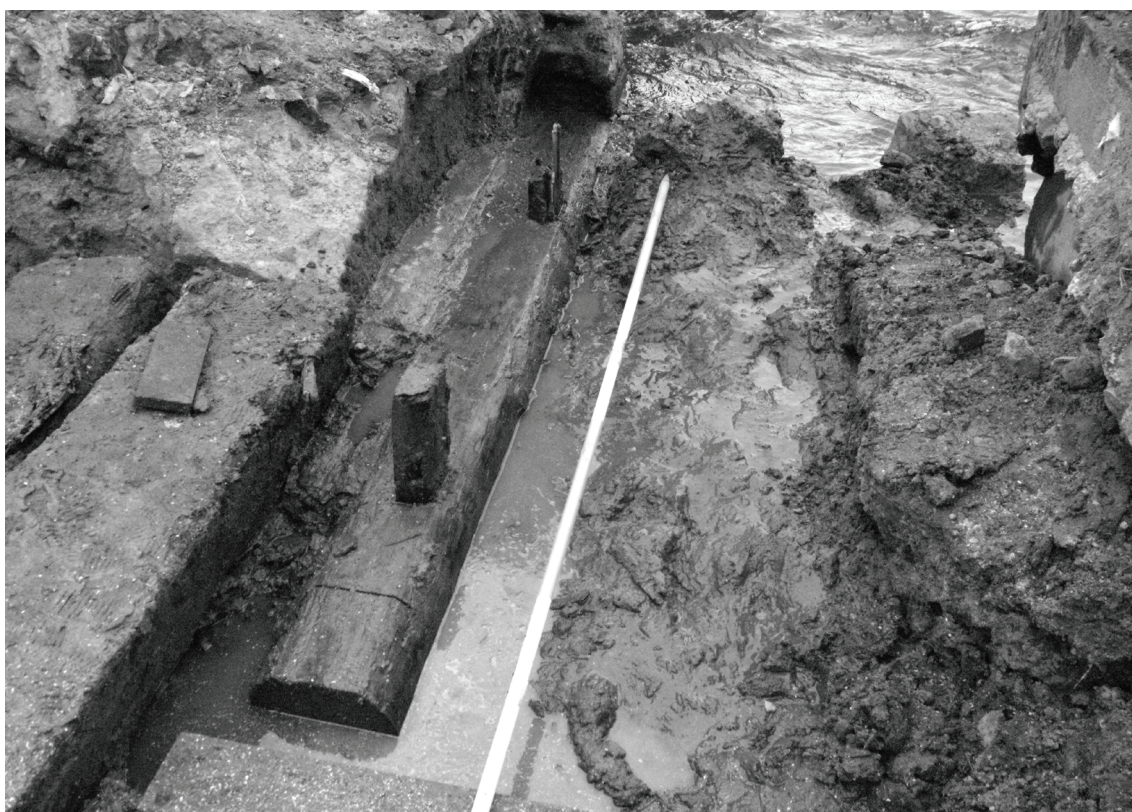
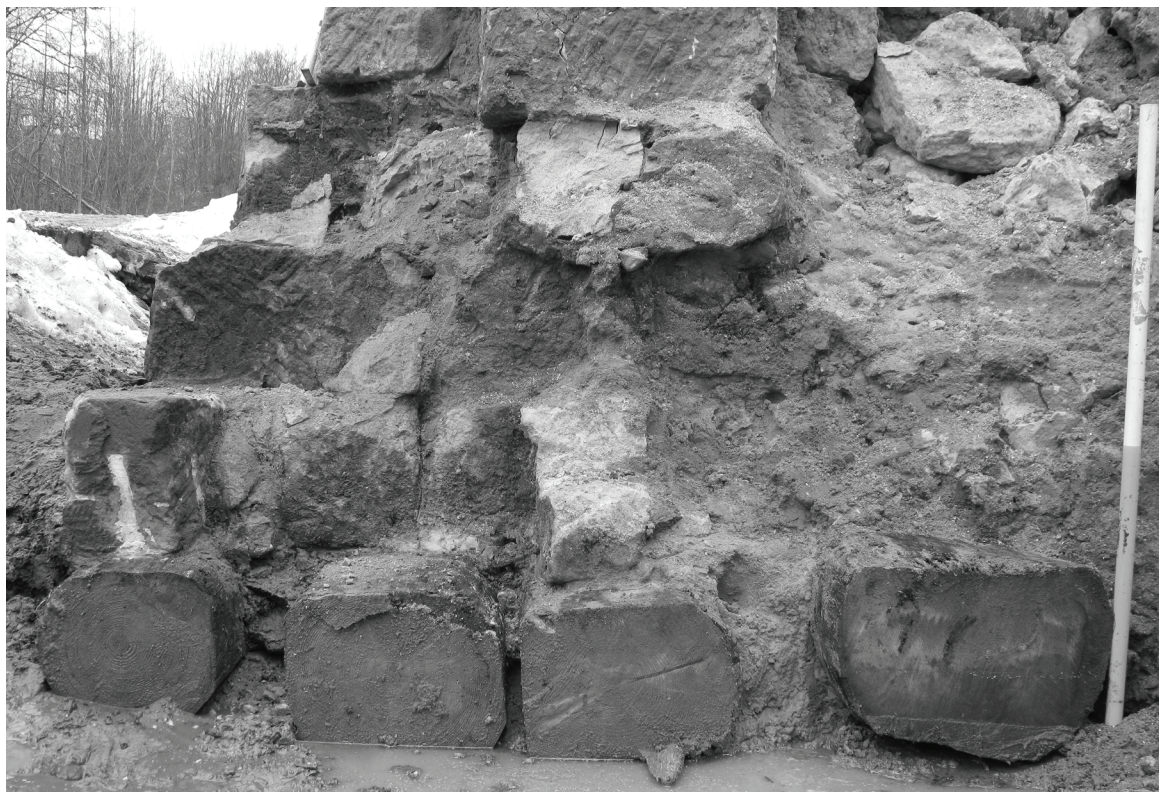
**Fig. 21.** The foundation of the 3<sup>rd</sup> bridge pillar of the Zámecký (Castle) bridge (source: VMG archive).

Fig. 22. The foundation of the 3<sup>rd</sup> bridge pillar of the Zámecký (Castle) bridge (source: VMG archive).

side, this beam was connected to another beam with a pin. Next to this beam, three more beams were laid. It was also possible to detect several levels of pavement through soundings, which proves the gradual increase in communication in the surface of the bridge. The findings date the top layer examined by detection technique to the turn of the 19<sup>th</sup> and 20<sup>th</sup> centuries. On the other hand, the modern pottery obtained from deeper layers can only generally be dated in the range of the 17<sup>th</sup> to 19<sup>th</sup> centuries. The research thus verified the assumption that the eastern and apparently also the central part of the bridge underwent major reconstruction during the 1<sup>st</sup> half of the 19<sup>th</sup> century, apparently in several stages caused by particularly serious damage after floods (Jenč *et al.* 2011, 60–61).
